TWO HALVES MAKE A HOLE

WHERE DID THAT TRANSMISSION LEAK COME FROM?

COULD BE A CRACKED TRANSMISSION OIL COOLER HOSE SADDLE.

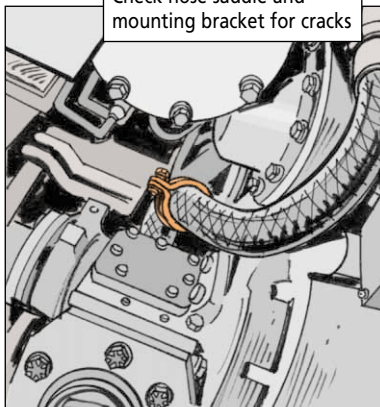
After extended use and a lot of vibration, the two pieces can develop cracks. The hose rubs against the cracked pieces until a leak develops. If the leak gets bad enough, the transmission is damaged.

Check hose saddle and mounting bracket for cracks

When the cab's raised during PMCS, eyeball the hose saddle and mounting bracket carefully for cracks or breaks. Then, get your mechanic to replace either part as necessary. He'll also need to replace the hose, NSN 4720-01-408-5669, if it shows excessive wear.
